Alert service bulletin no. SB02/2016

Subject: Fabric coating of wings, horizontal tail and vertical tail rudder on all types of ZEPHYR aircraft

Date of issue: 1.9.2016

Affected products: ZEPHYR, ZEPHYR 2000 and ATEC 122 Zephyr

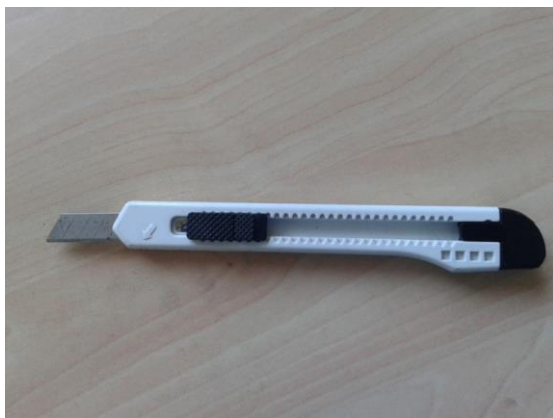
Pic. 1: example of the tool suitable for inspection of coating attachment

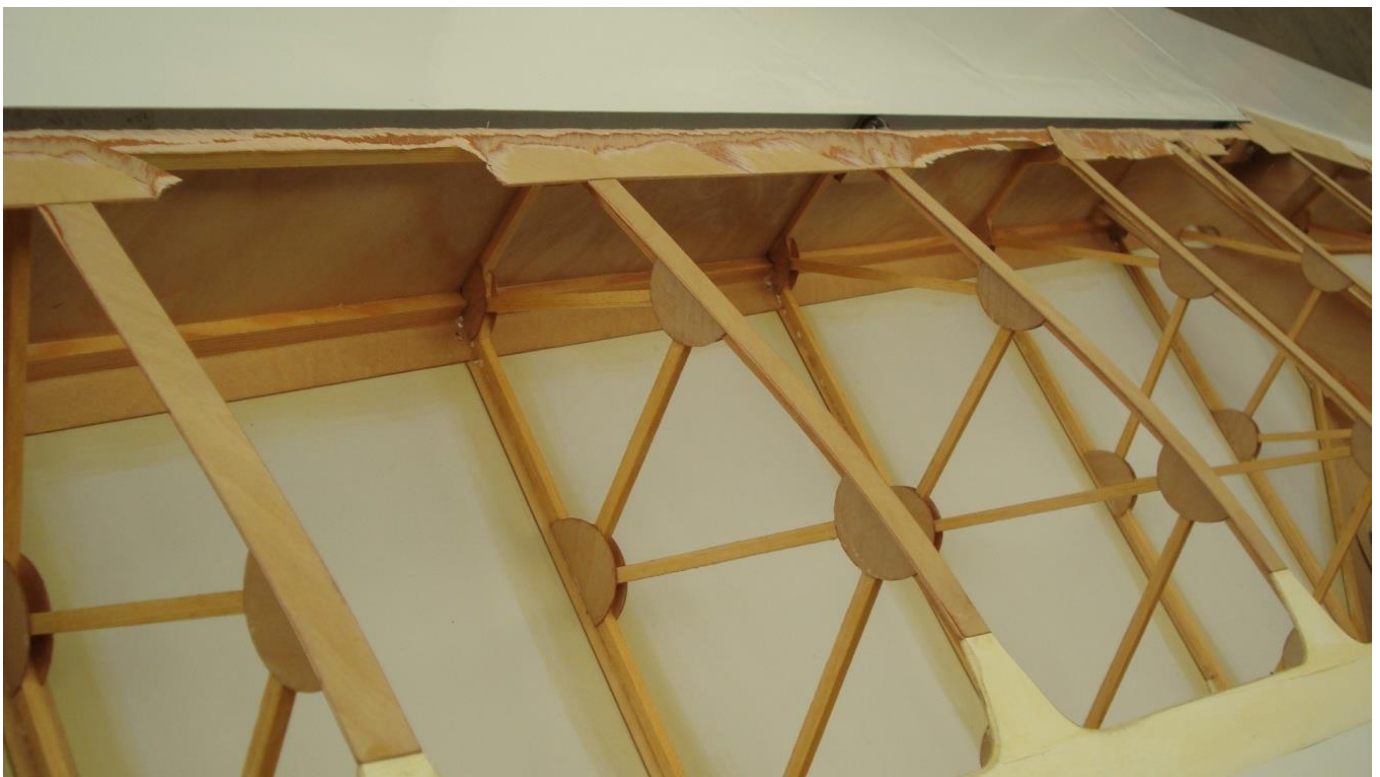
A separation of the fabric coating from the right wing in-flight was observed at ATEC 122 Zephyr airplane. The airplane returned to the airport and safely landed. The incident occurred due to exceeding of the lifetime of the coating which is 10 years since the airplane came into operation as stated by its manufacturer. The material lifetime can be shortened due to poor condition of the fabric bonding caused by extremely unsuitable climatic conditions. Improper adherence of the fabric coating is indicated by slight lifting or detachment of the fabric on bonded edges or identified by easy intrusion of an applicable sharp thin tool between the fabric coating and inside wing structure. In such case the airplane is considered as not airworthy and it is necessary to make re-coating of all parts of the airplane.

Pic. 2: Fabric coating separated from the upper part of the wing

Check the bonding of the coating on wings and horizontal tail before next flight. There must not be any visible crack between the fabric coating and hard surface of the wing. If even limited detachment of the coating is observed, try to input any sharp tool into that slit and gently pass the tool through it to check its depth. If the tool is able to easily intrude between the coating and wing structure, it is necessary to remove the aircraft from service and to make its complete re-coating. If the tool is not able to intrude into the slit, bond the slit by contact glue to avoid water intrusion between the fabric coating and wing structure and so to avoid further degradation of bonding. We recommend to cover the bonded connection situated on torsion box of the wing and horizontal tail by white plastic tape of 25mm width. The tape shall be placed in a position to cover the connection of torsion box and coating by its middle part.

Check the bonding condition same way as described by the par. 1. Then, cover the connection on the torsion box of the wing and horizontal tail by white plastic tape. Ask the aircraft producer or its authorized workshop for re-coating.

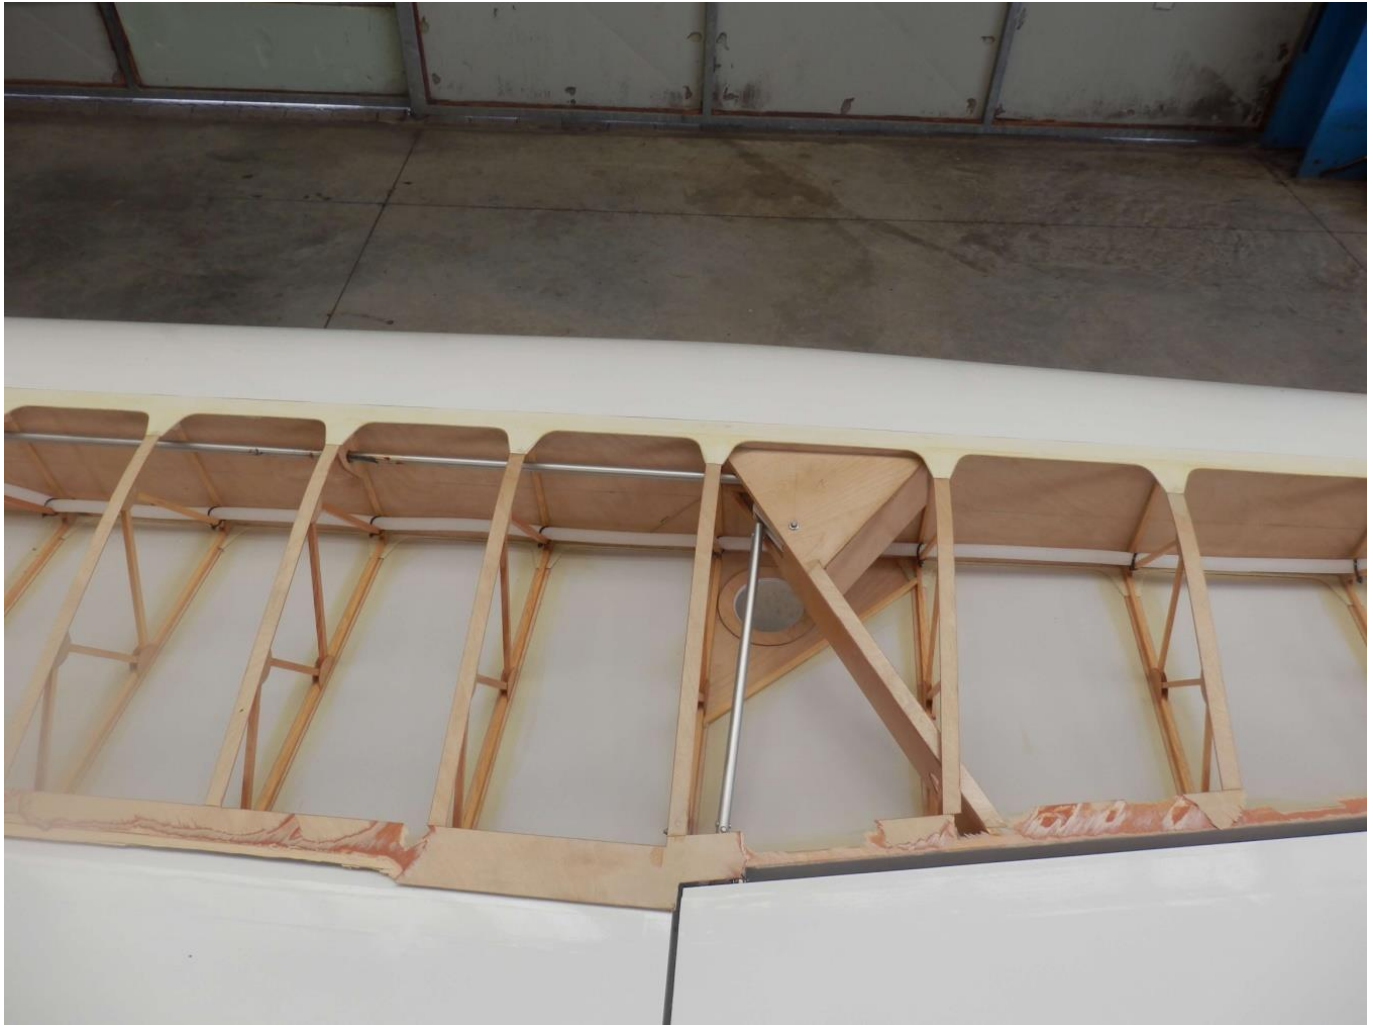
Pic. 3: Fabric coating separated from the upper part of the right wing

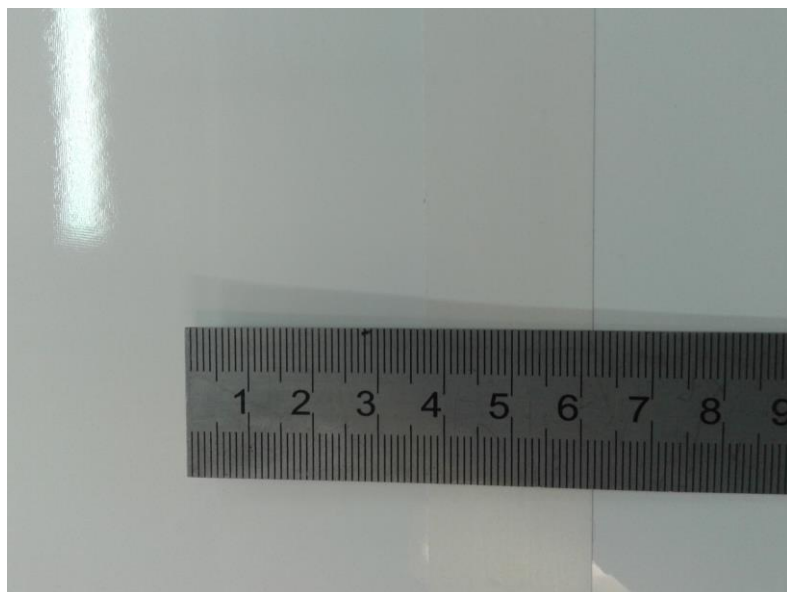
Pic. 4: Detail of the tape covering bonded connection of the coating on torsion box

3. The producer extended the width of bonded connection on torsion box of the wing. The original width of 35mm is now extended up to 50mm. The connection is covered by white plastic tape.

We recommend to cover all bonded connections situated on torsion box of wings and horizontal tail by white plastic tape of 25mm width. The tape shall be placed in a position to cover the connection of torsion box and coating by its middle part.
