ALERT SERVICE BULLETIN no. SB01/2025 with influence on safe operation

Subject: Inspection of the fitting of the horizontal tail (HT) for cracks

Issuance date: 10.3.2025 No. of pages: 3

All airplanes with tailplane in T-arrangement, i.e. types ZEPHYR, ZEPHYR 2000, ATEC 122 Zephyr, ATEC 321 FAETA, ATEC 322 FAETA

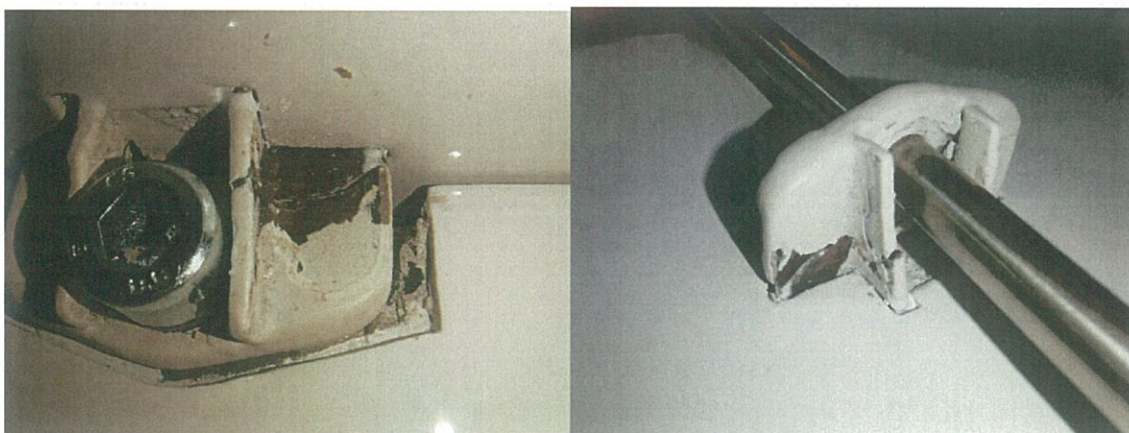
During the regular inspection of the ATEC 122 Zephyr with 9000 flight hours, the crack was discovered on one side of the fitting of the horizontal tailplane with a T-arrangement.

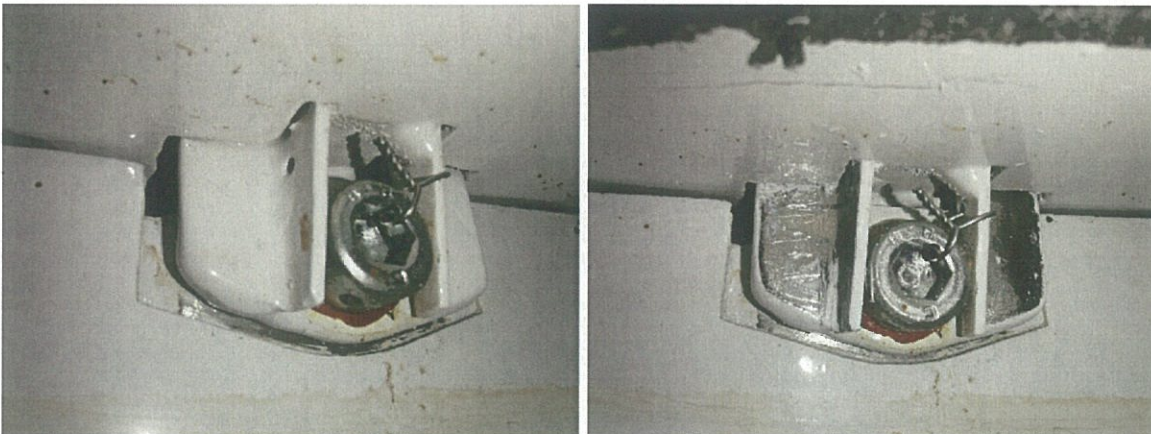
Visually check the stainless steel fitting for incipient micro cracks occurrence. Check if possibly incipient crack occurs on the fitting when applying a for-/backward pressure on the end bow of the horizontal tailplane.

Grind away the paint from the fitting by any sharp instrument, but pay attention not to make scratches in the weldment!
