Alert service bulletin no. SB02/2016

Subject: Fabric coating of wings, horizontal tail and vertical tail rudder on all types of ZEPHYR aircraft

Date of issue: 1.9.2016

Affected products: ZEPHYR, ZEPHYR 2000 and ATEC 122 Zephyr

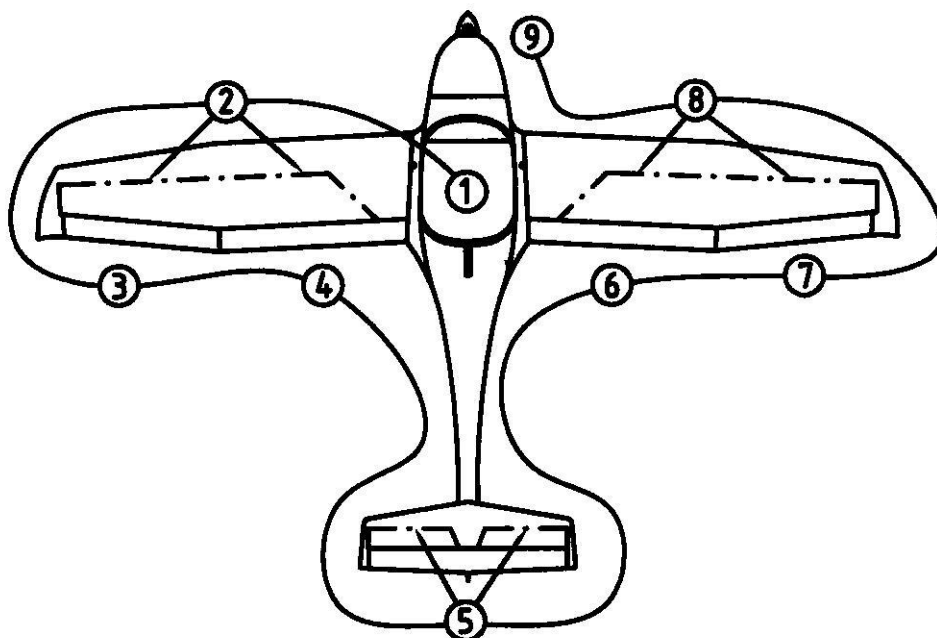
4.1. Pre-Flight Inspection

- 1/ Cockpit – switches, seat belts, instruments, seats, controls, canopy locks, canopy condition check
- 2/ Left wing – coating and fabric bonding condition*, play, Pitot tube

- 3/ Left aileron – coating and fabric bonding condition*, free movement, attachments, controls
- 4/ Left flap – coating and fabric bonding condition*, attachments, controls, play
Left main gear leg – condition, brake fluid leak, wheel spat

- 5/ Tail – surface condition, coating and fabric bonding condition*
VT – surface, attachments, control
HT – coating, attachments, fitting covers
Rudder – surface, attachments, control

- 6/ Right flap - coating and fabric bonding condition*, attachments, controls, play
Right main gear leg - condition, brake fluid leak, wheel spat
- 7/ Right aileron - coating and fabric bonding condition*, free movement, attachments, controls

- 8/ Right wing – coating and fabric bonding condition*, play
- 9/ Nose wheel – condition, play, wheel
Engine – operation liquids amount, engine cowling
Propeller – condition, spinner tightness

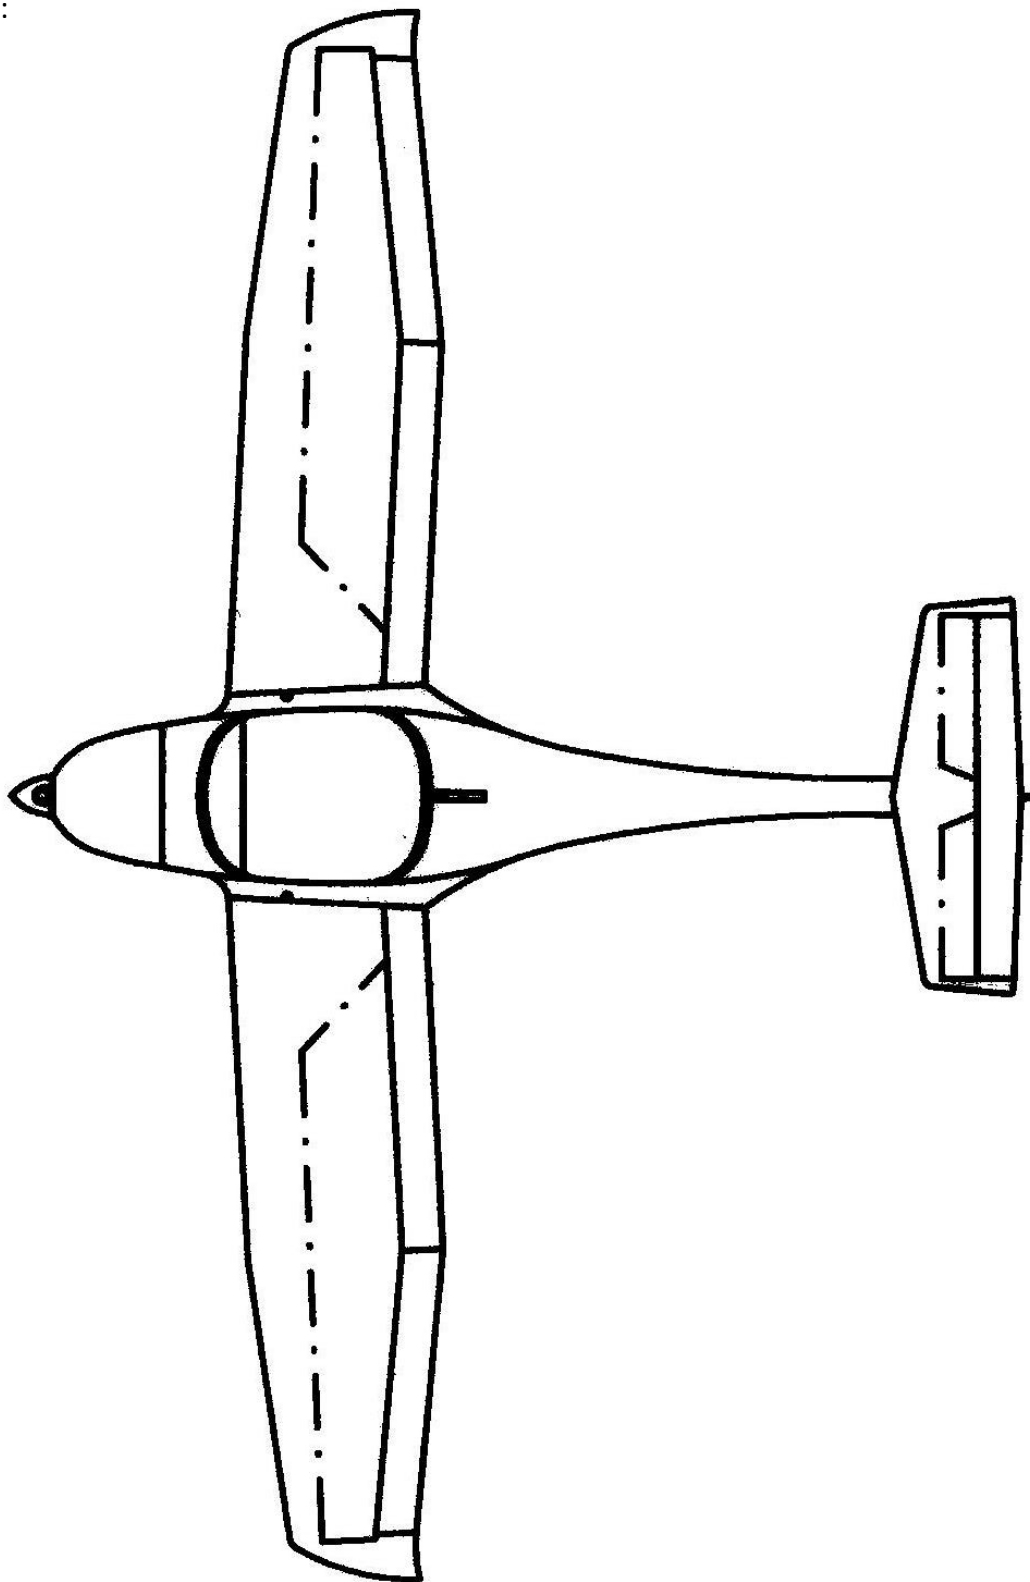
View from above:

There can not be any visible crack between the fabric coating and hard surface of the wings/ elevator/rudder. If even limited detachment of the coating is observed, try to input any sharp tool (e.g. knife) into that slit and gently pass the tool through it to check its depth. If the tool is able to easily intrude between the coating and wing structure, it is necessary to remove the aircraft from operation and to make its complete re-coating. If the tool is not able to intrude into the slit, bond the slit by contact glue to avoid water intrusion between the fabric coating and wing structure and so to avoid further degradation of bonding.

We recommend to cover all bonded connections situated on torsion box of wings and horizontal tail by white plastic tape of 25mm width. The tape shall be placed in a position to cover the connection of torsion box and coating by its middle part.
